# TOWN OF WINDERMERE

## MULTI MODAL AND SAFETY ANALYSIS

AUGUST 2015

***Kimley-Horn and Associates, Inc.***

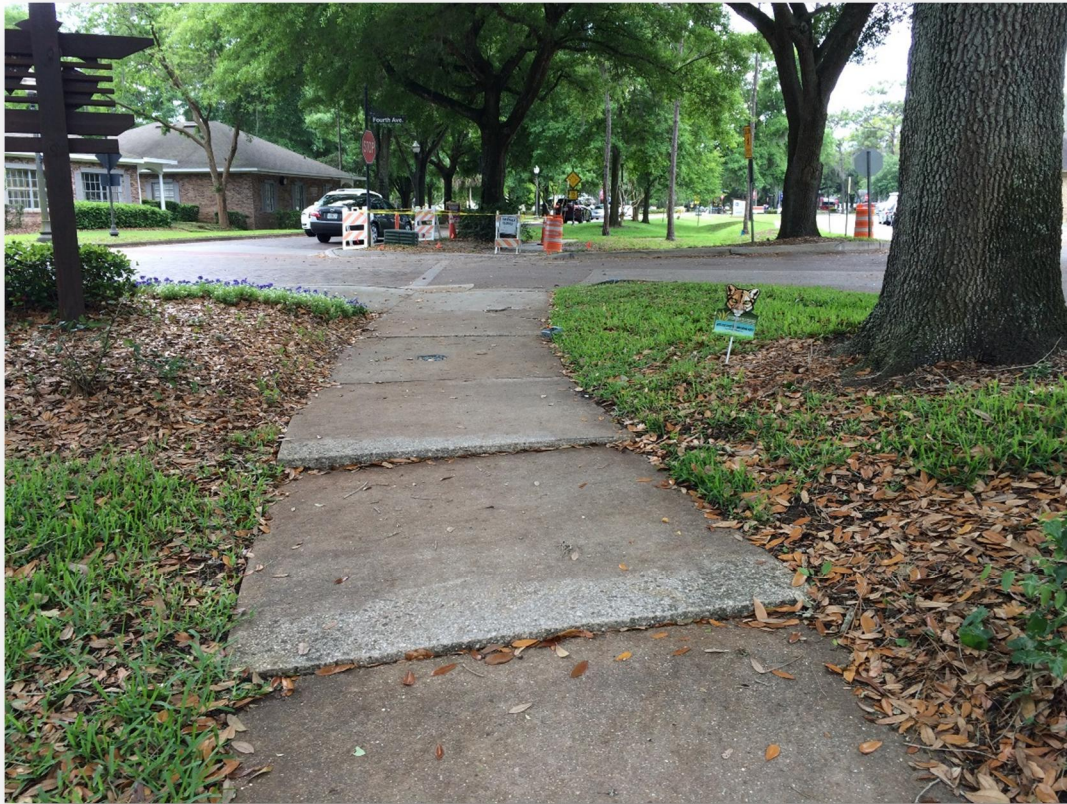
Many of the existing sidewalks are only partially usable due to their condition or need for maintenance. For example, some sidewalks are badly cracked, with large portions that are not traversable. Other sidewalks are covered with dirt from the adjacent dirt road. If the dirt was removed, it would likely return quickly, likely after the first significant rain event. Therefore many of the sidewalks in town are not conducive to traveling on a bicycle, in-line skates, or on a skateboard. Several of the sidewalks have settled differently or been uprooted, resulting in vertical differences that are tripping hazards. Any vertical difference greater than one fourth of an inch should be repaired, based on ADA requirements. **Exhibits 3, 4, and 5** provide examples of poor sidewalk conditions.

Exhibit 3 – Example of sidewalk joints with tripping hazards

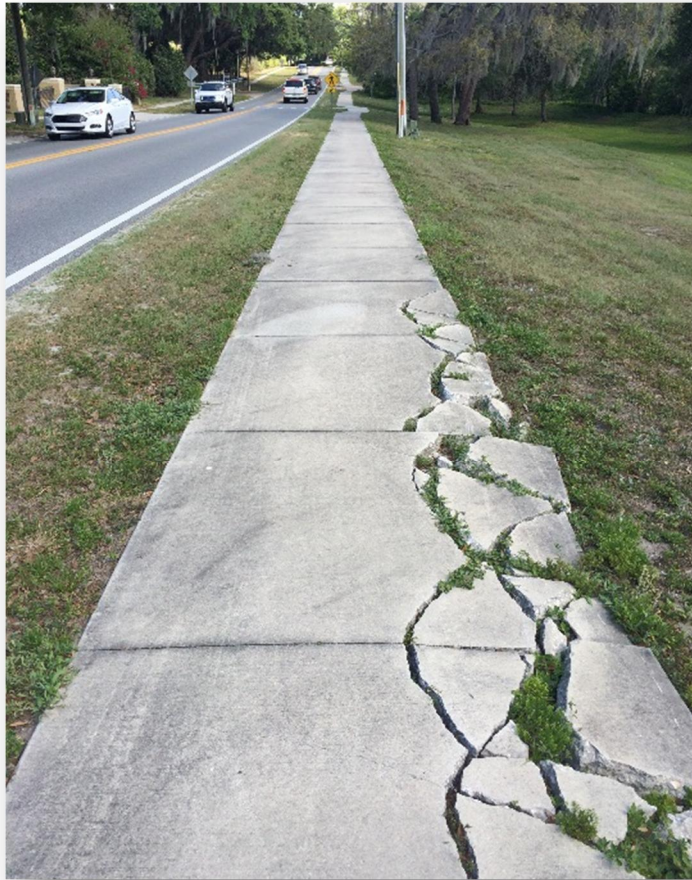
Exhibit 4 – Sidewalk on the South Side of 6th Avenue, just east of Lake Street.

The pedestrian activity at this location was observed on a weekday afternoon. No pedestrian crossings were observed in this time period. It is also noted that the sidewalk along 6th Avenue on the south side of the road near the crosswalk is in poor condition.

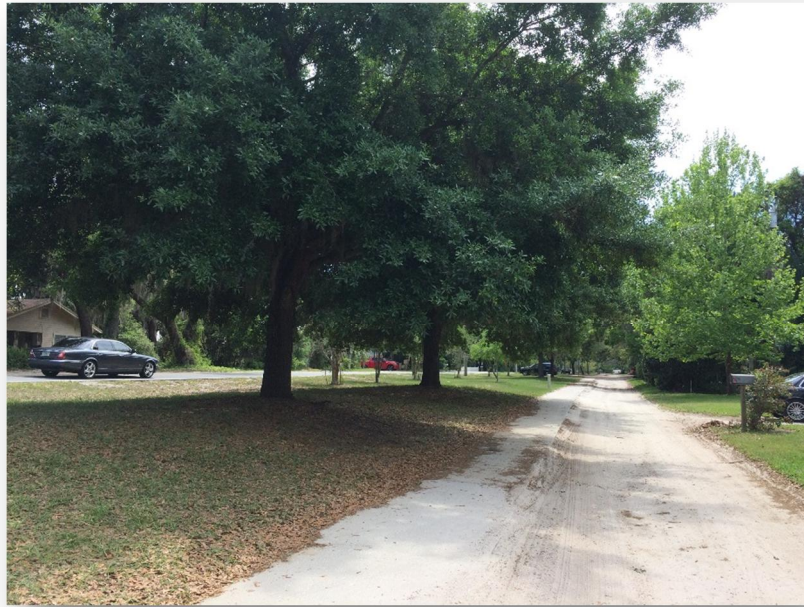
Exhibit 5 – View of Old Main Street, looking south, between the canal and North Drive

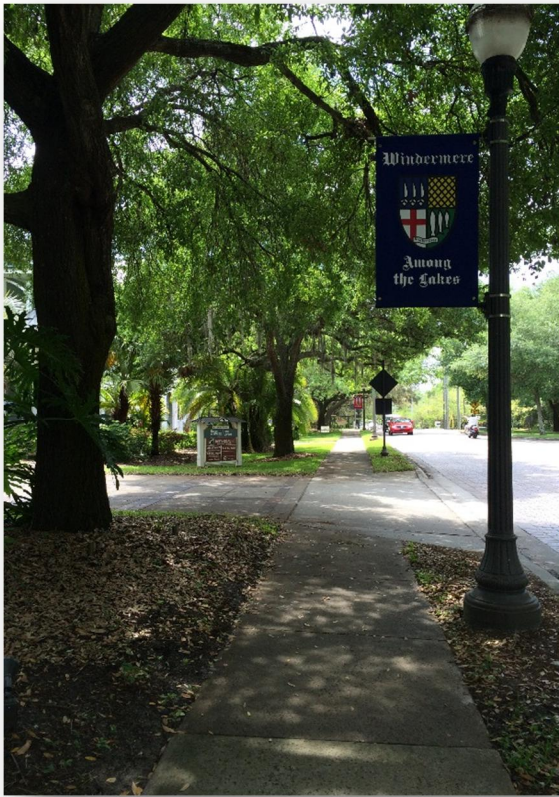
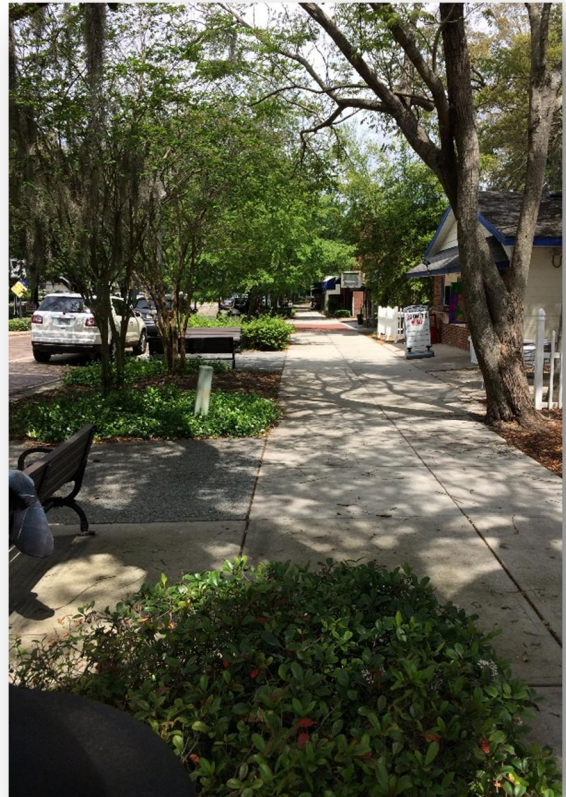
Though there are several areas where the sidewalk conditions have deteriorated to some degree, there is an overall positive experience for pedestrians, particularly in the downtown area. Downtown Windermere is very walkable, with abundant amenities, large shade trees, and sidewalks. Pictures of sidewalks in the downtown area are provided in **Exhibit 6**.

Exhibit 6 – Two examples of shaded sidewalks along Main Street

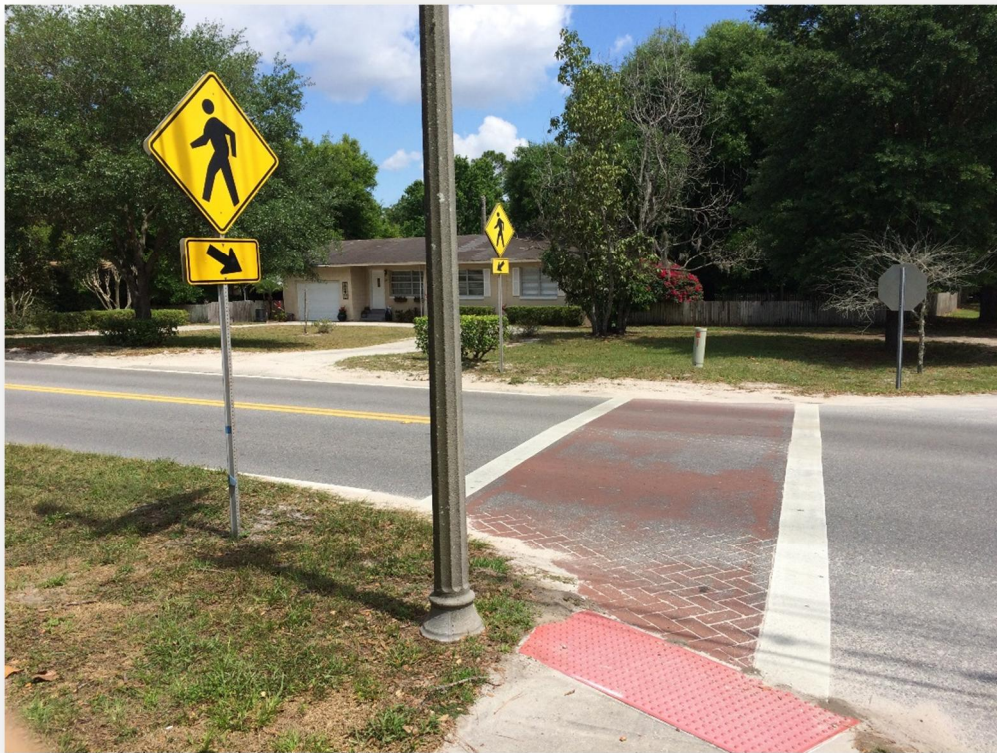
The crosswalk at 2<sup>nd</sup> Avenue extends into grass, with no sidewalk or landing on the east side of the road. This is shown in **Exhibit 7**. The ramp and pedestrian detection surface on the west side should be realigned with the middle of the crosswalk and point directly across the road.

Exhibit 7 – Crosswalk at 2nd Avenue

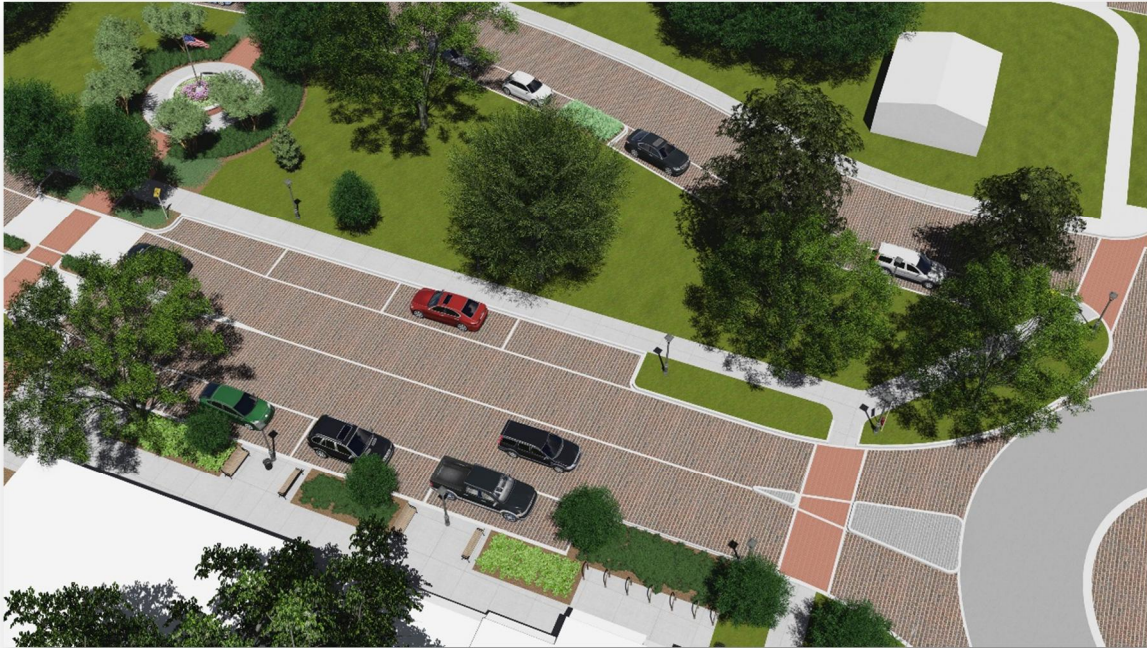
Much of downtown Windermere already has sidewalks on both sides of Main Street, a sidewalk on the west side of Old Main Street, and Old Main Street is designated as Golf Cart Friendly. A new multi-use facility would not be well utilized in these areas since so many modes are already accommodated. The redundancies are illustrated conceptually in **Exhibits 8 and 9**, which show existing conditions and a potential path alignment, respectively. Additional views are provided in **Appendix C**. Due to the availability of multiple options to travel through downtown, it would be difficult to obtain funding for an additional path. As such, in areas that already have sidewalk, the likely recommendation is to replace the existing sidewalk with a wider asphalt path.

Exhibit 8 – Existing View of Main Street and Old Main Street through Downtown Windermere

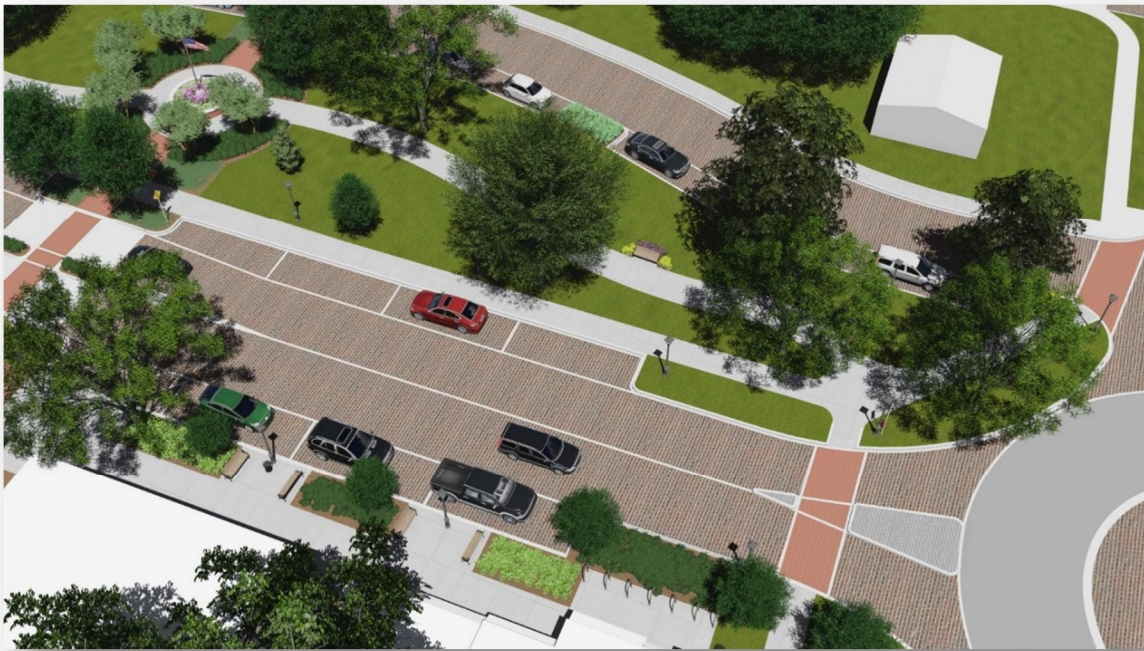
Exhibit 9 – Conceptual Multi-Use Path through Downtown Windermere

The old railroad alignment was considered as a potential alignment for a multi-use path. Recognizing that several roads parallel to Main Street are designated as Golf Cart Friendly Roads, it is not critical to provide golf cart travel options along Main Street. It is, however, critical for the bridge over the canal to be wide enough to accommodate golf carts. In areas that have no sidewalk now, the old railroad alignment is likely the preferred location to build a new path.

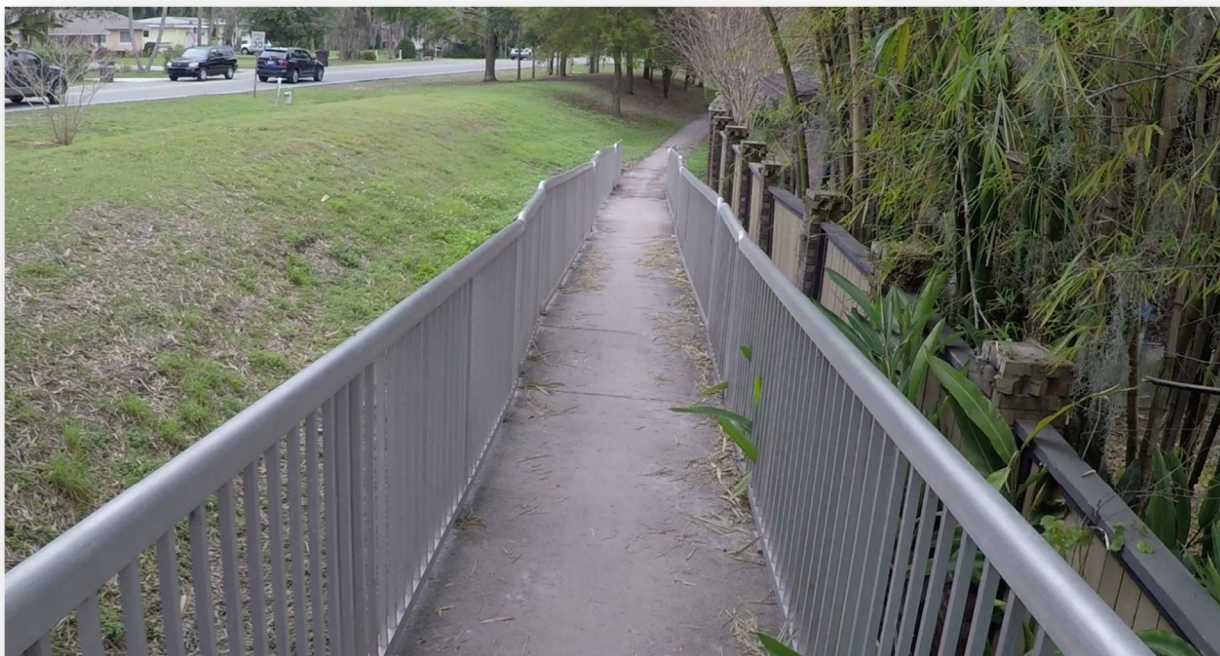
The walkway approaching the bridge is steep and narrow, as pictured in **Exhibit 10**. The north side of the bridge includes a section of two 90° turns near the top, as pictured in **Exhibit 11**. It is possible that some golf carts can traverse the bridge, but many are likely not narrow or maneuverable enough to even try.

**Exhibit 10 – Narrow Path to Existing Pedestrian Bridge**

A new bridge should facilitate golf cart travel between the north and south portions of the town. A new bridge should be wide enough for multiple modes to travel on the bridge without causing conflicts. The preferred typical section should be determined based on community outreach and costs. Design elements to include are an improved slope on the ramps, a typical section that is wide enough for golf carts, bicycles, and pedestrians, aesthetic improvements, and a clearance height under the bridge that is equal to or greater than the clearance height of the adjacent bridge.

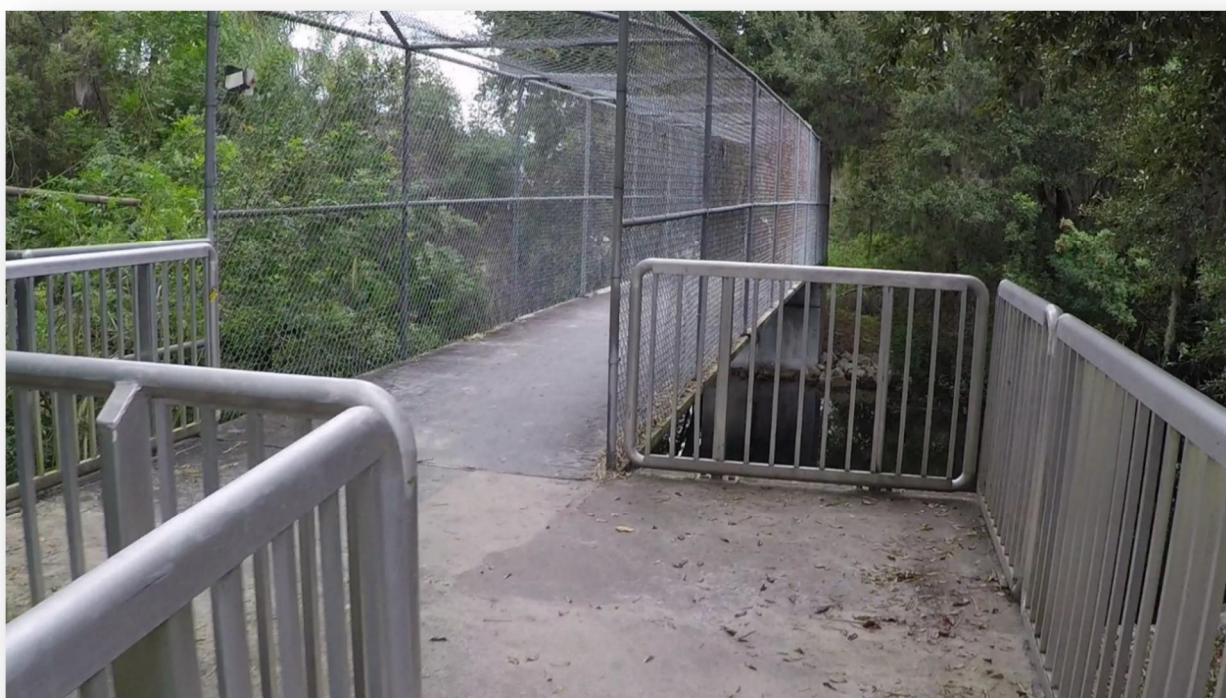
**Exhibit 11 – Sharp Turns Approaching Pedestrian Bridge**

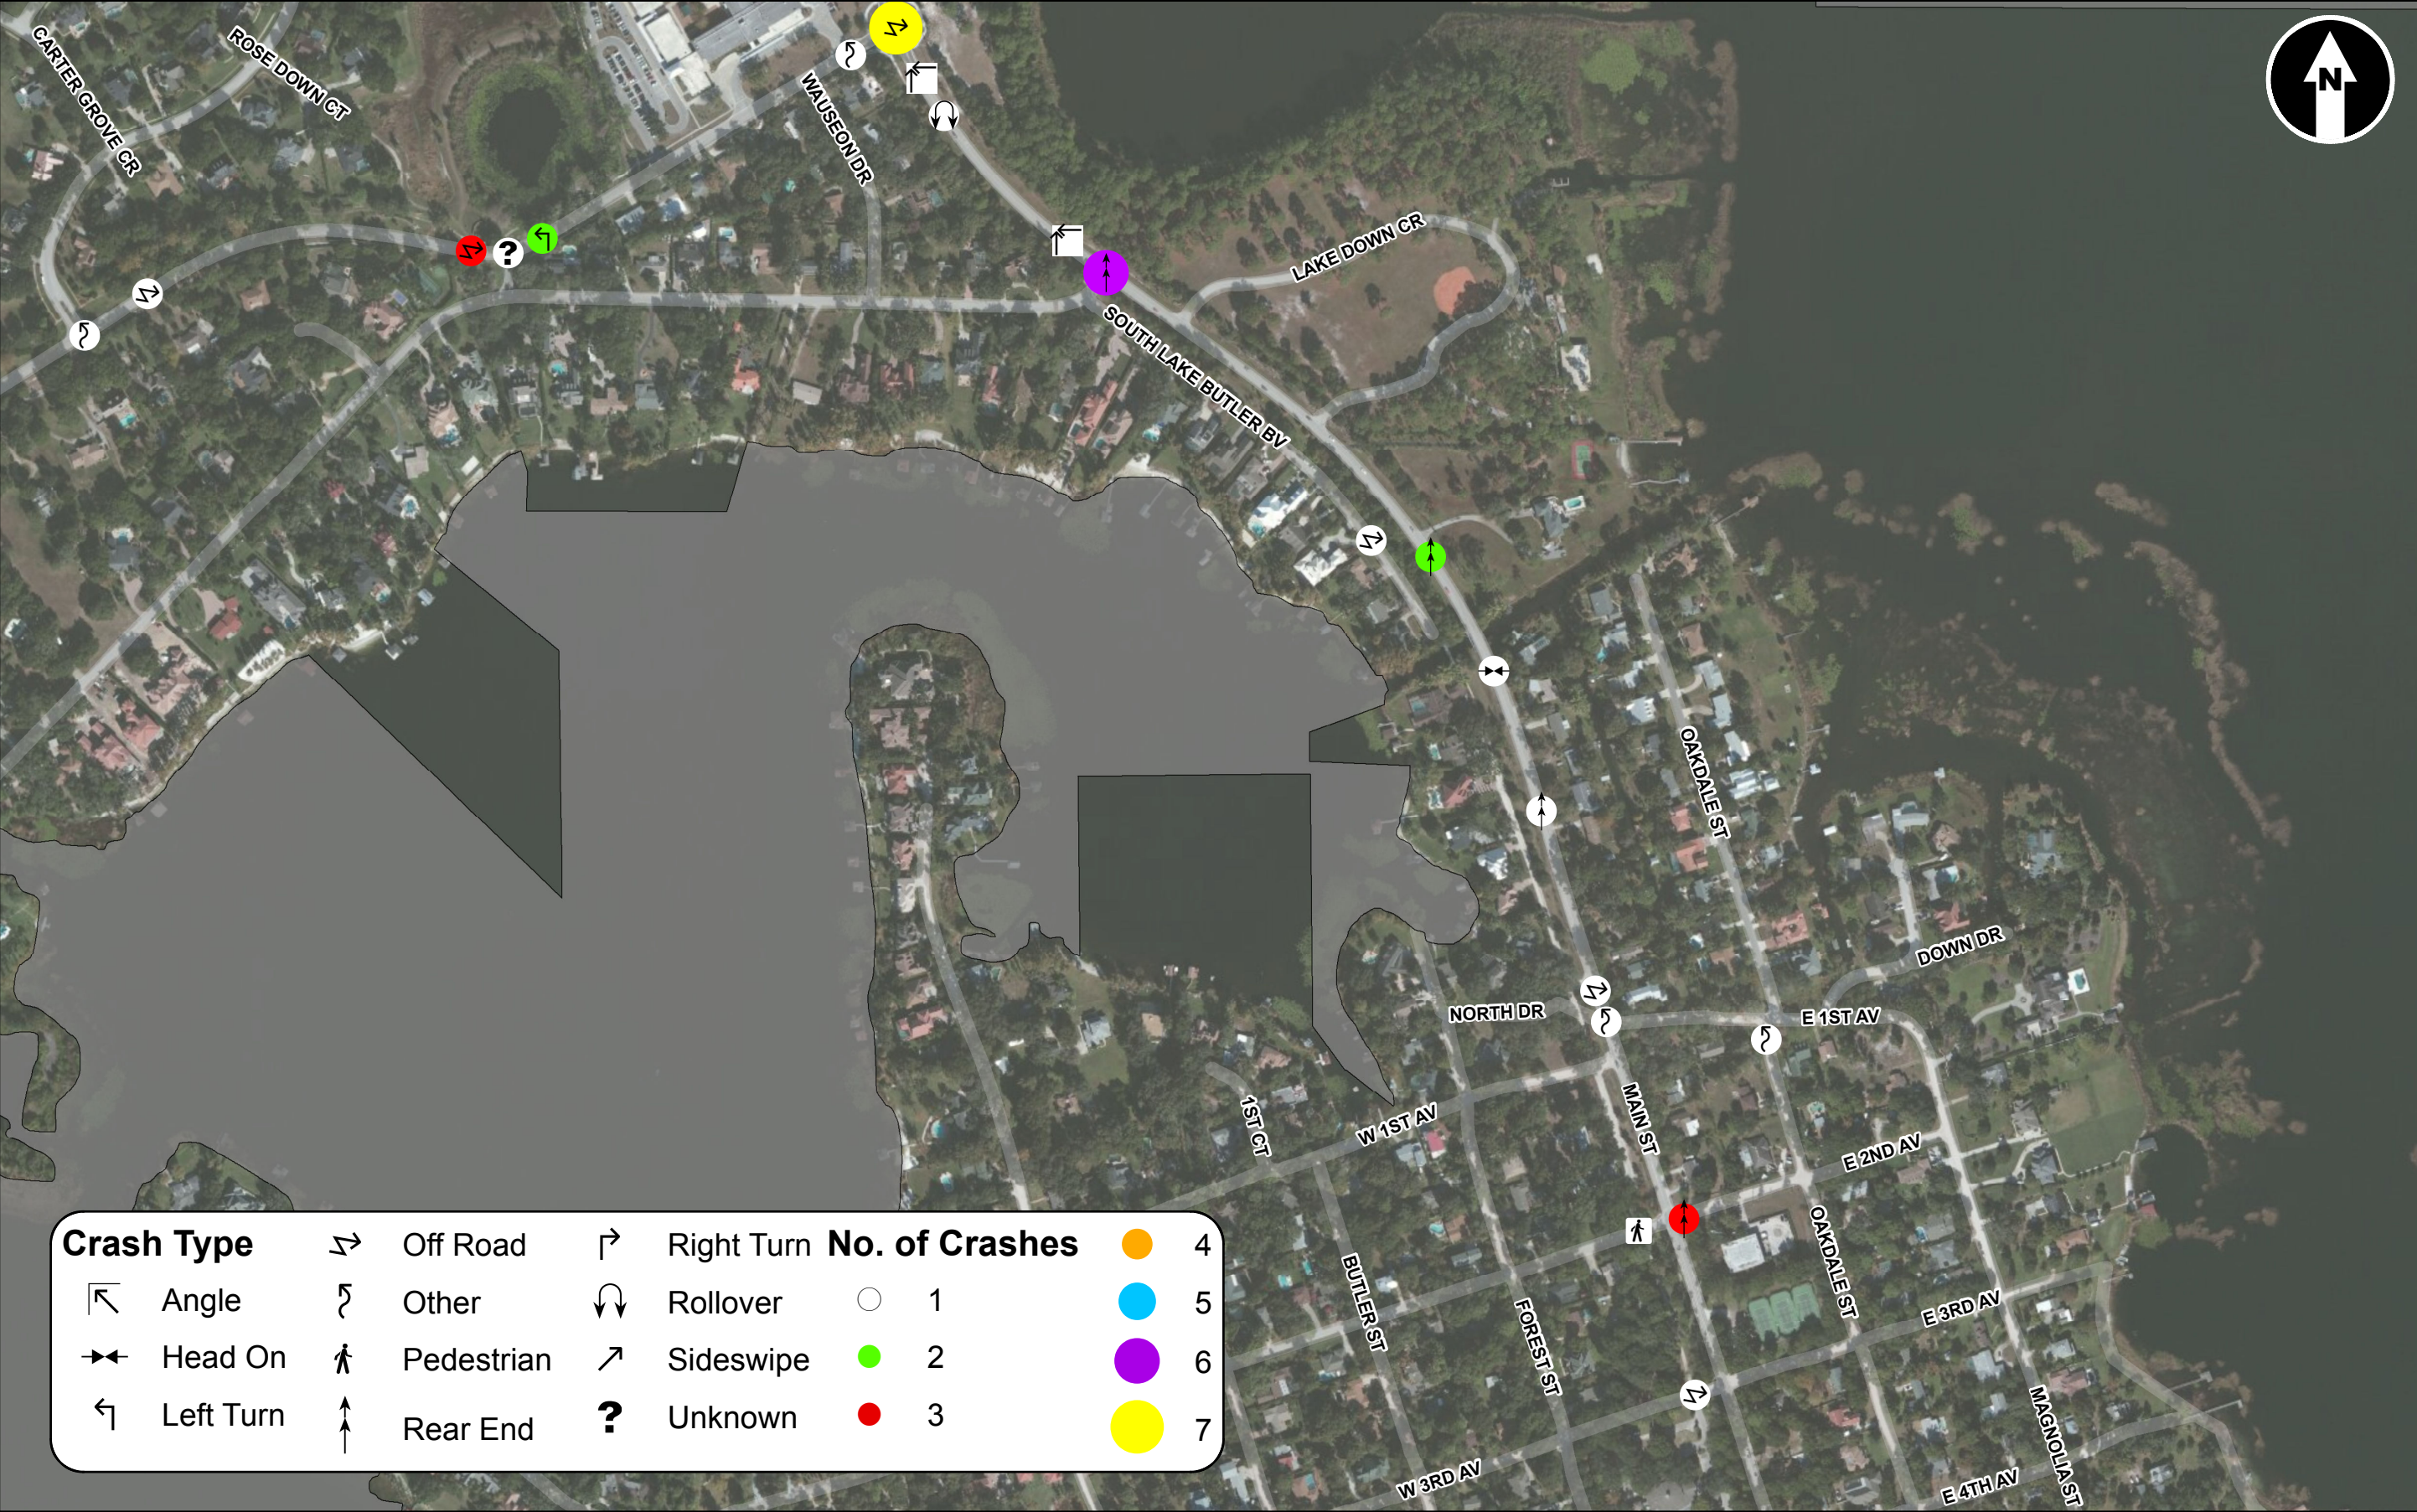
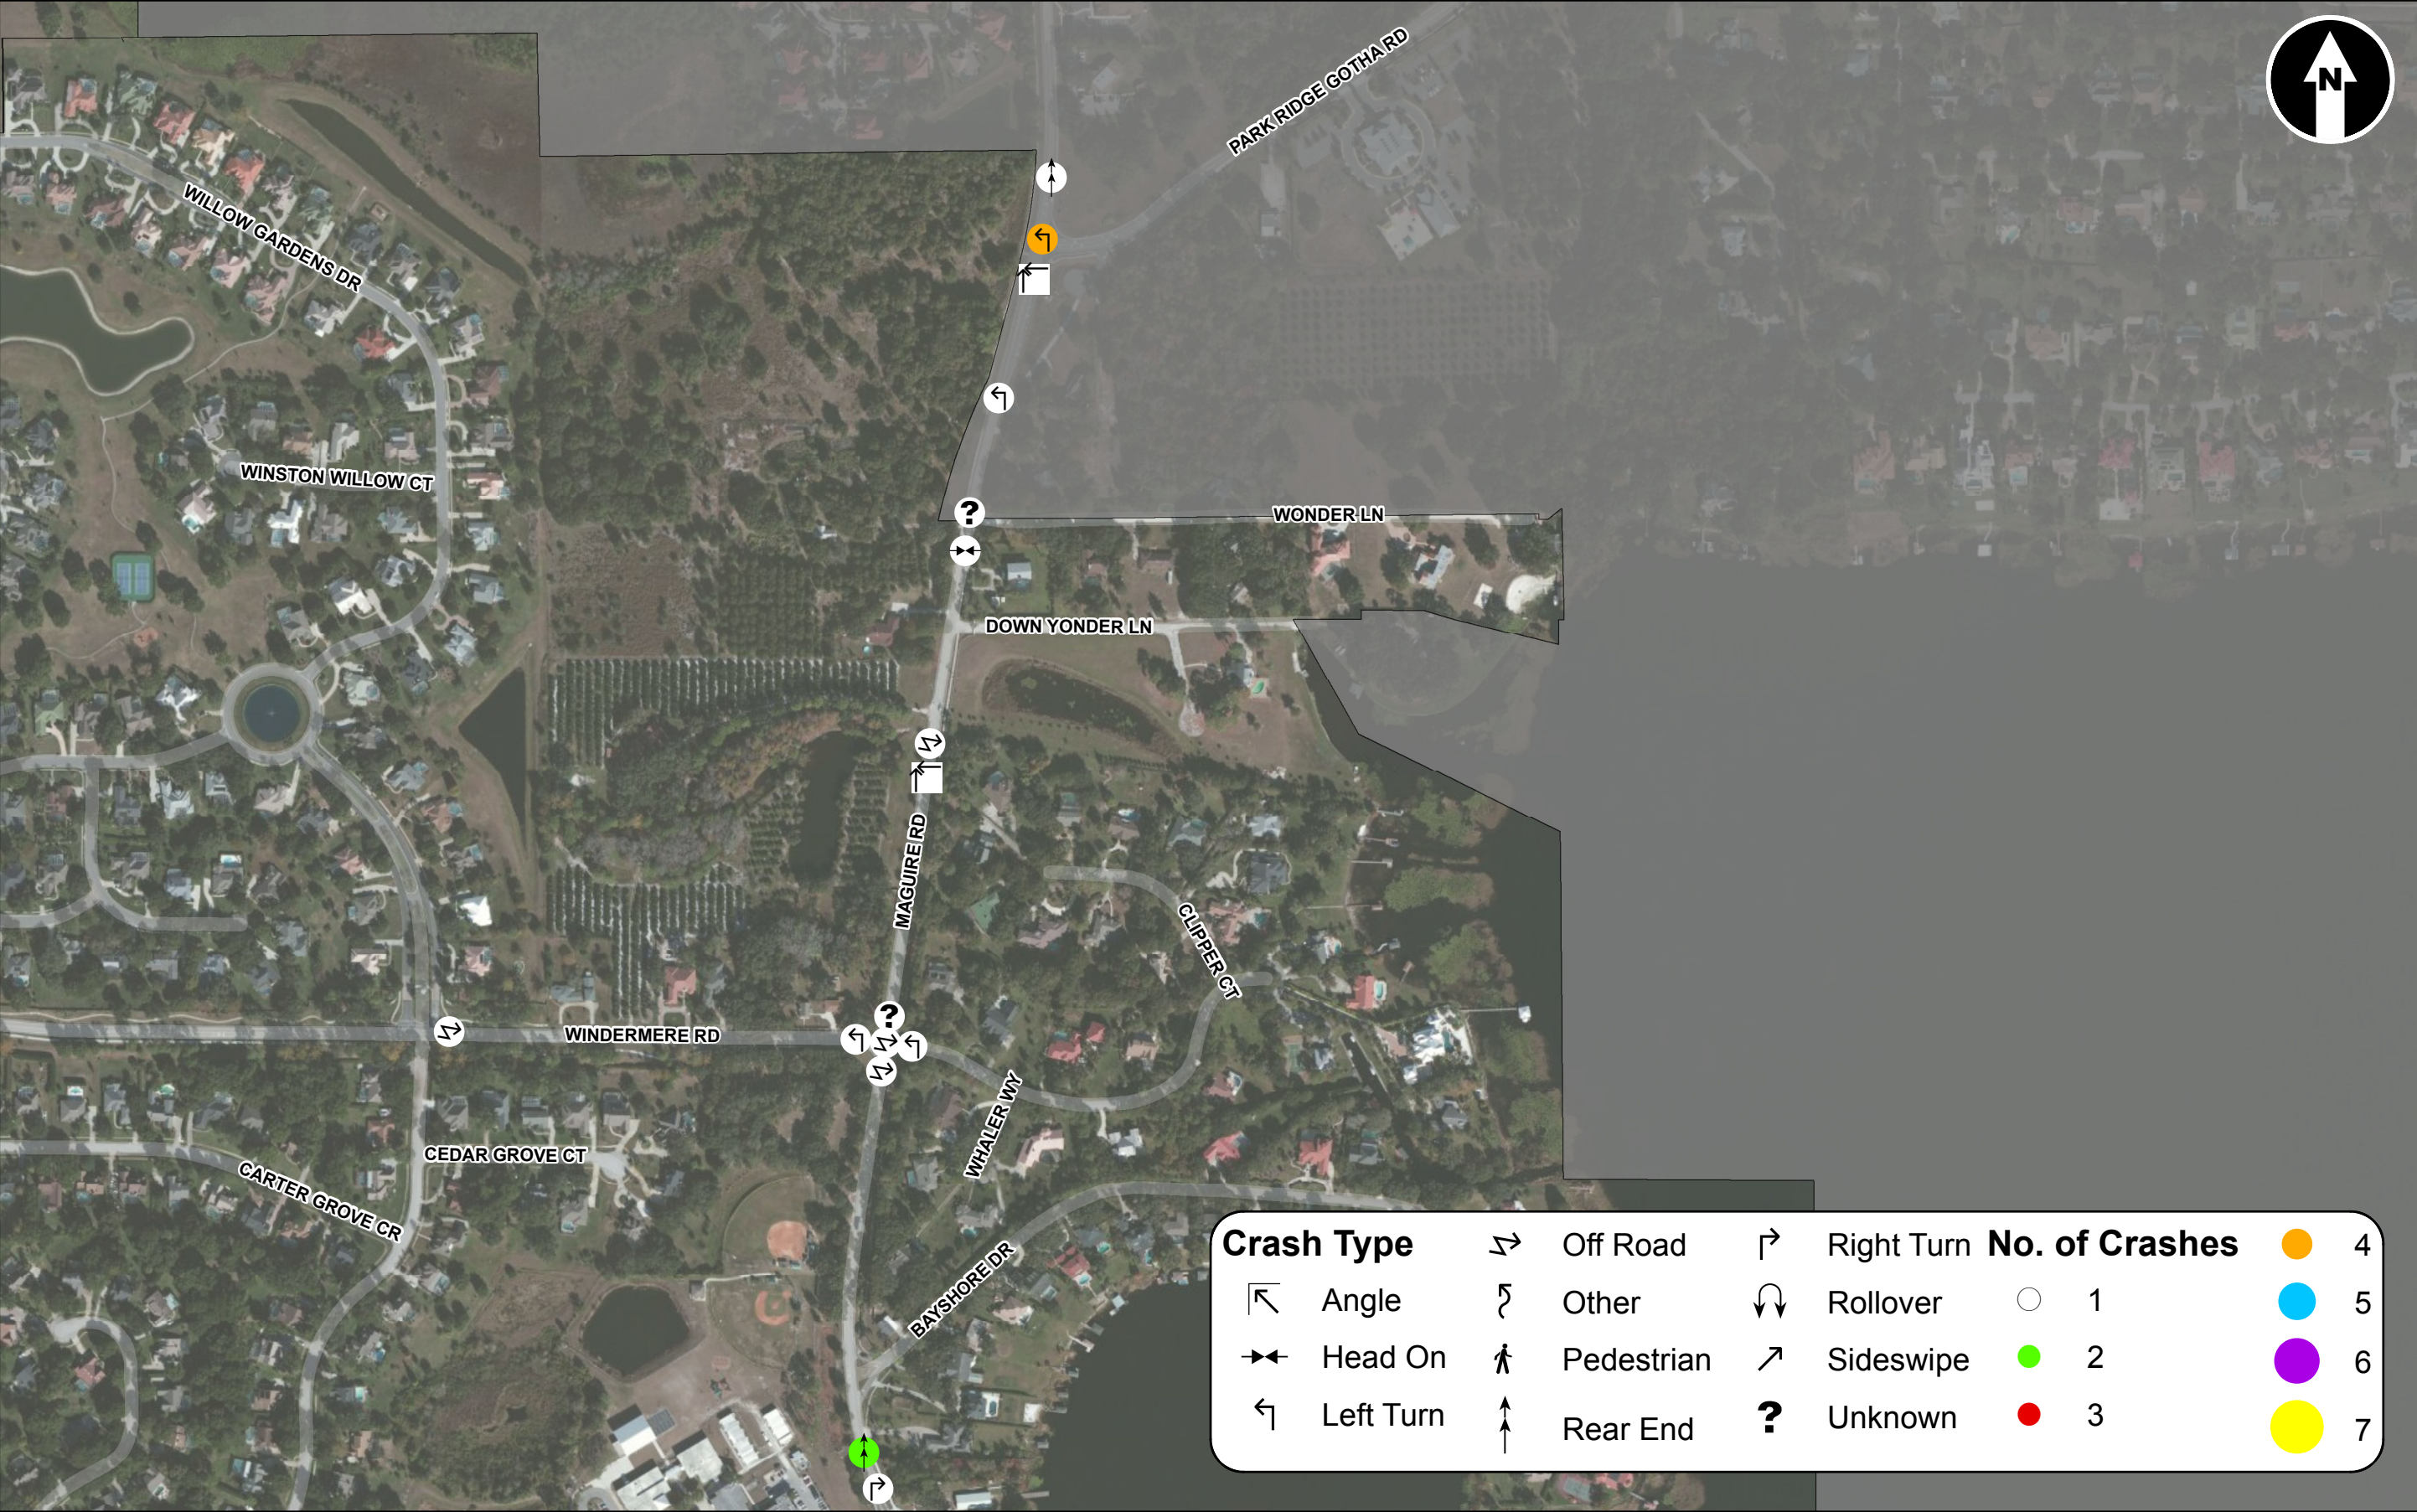
**CRASH DATA**

Five years of crash data were obtained, covering the period from January 2011 to January 2015. All roads within the Town of Windermere were considered. Crashes are shown over aerial photography based on the crash type in **Appendix A**.

Crashes in Windermere are generally concentrated near intersections, consistent with typical findings. As shown in the table, most of the crashes are Rear End collisions. Based on the narratives in the crash reports, many of these collisions were caused by distracted driving.

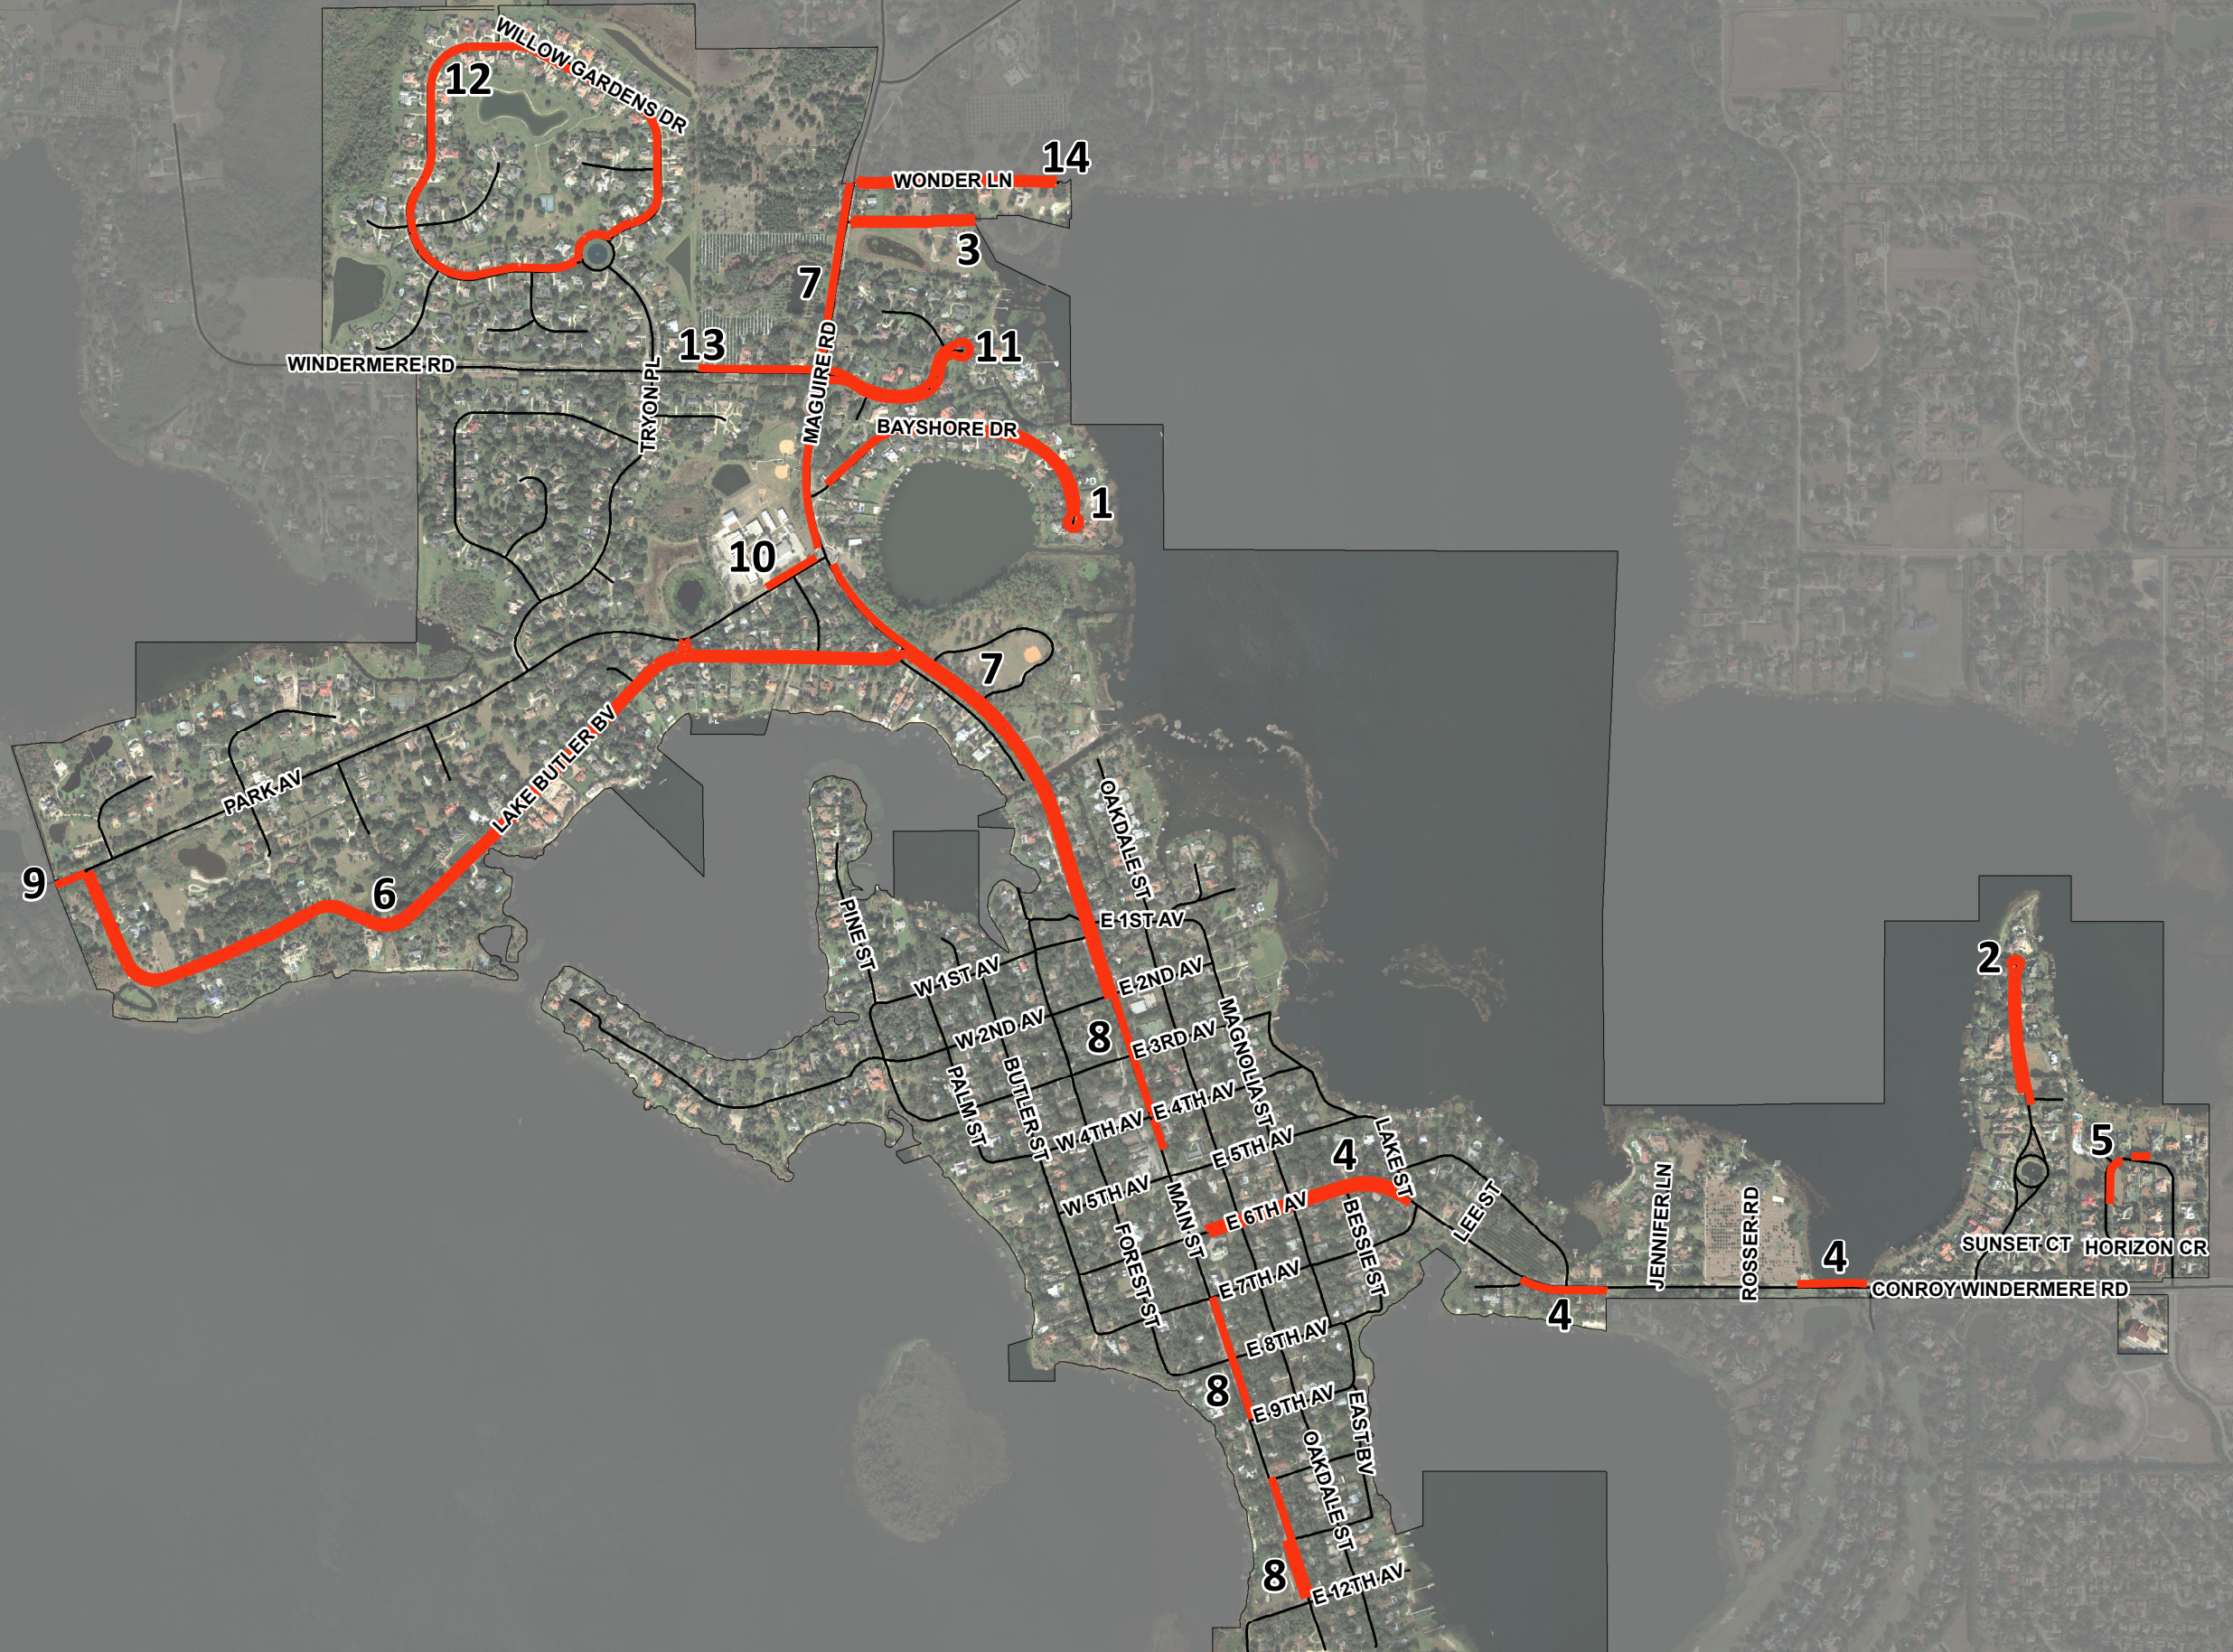
Several areas within the Town of Windermere lack sidewalks. Many of the roads with sidewalk gaps are high traffic roads that are not easy to cross and therefore should have sidewalks on both sides. The gaps are mapped in **Appendix B**.
